Technical Announcement

INDUSTRY AUTOMATION BU, DELTA ELECTRONICS, INC

Delta is pleased to announce the immediate release of new DOPSoft version 2.00.04.09 patch for DOP series HMI. This release is an improvement, which includes new HMI model and bug fixes.

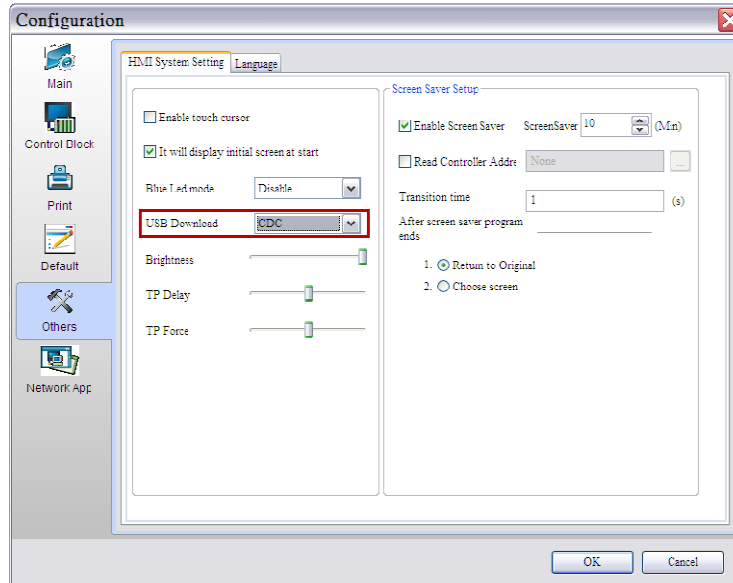
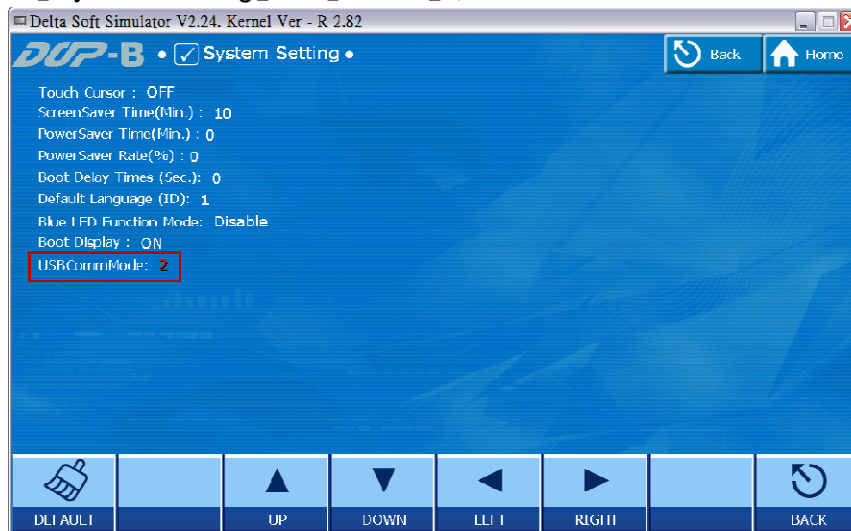
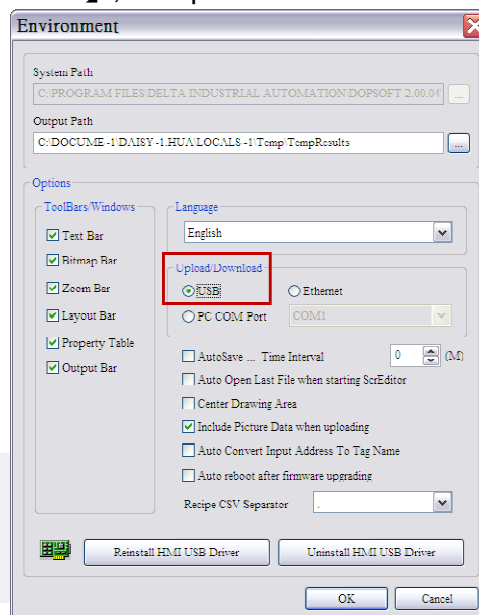
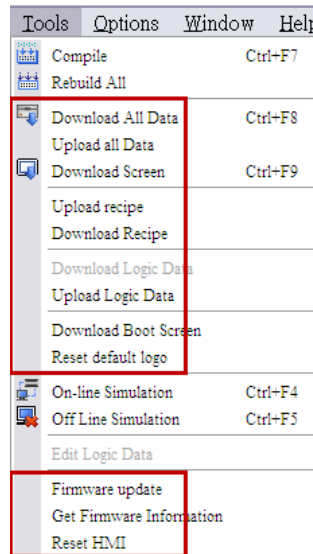
1. Fixed when upload/download HMI through CDC mode will cause error message “ No Response From HMI! ”.

DopSoft will pop up error message “ No Response From HMI! ”.

Step 1. Into **【Options】** → **【Configuration】** → **【Others】** , set USB Download to CDC.

Or Into System Menu **【System Setting】** → **【MISC.】** ,set USBCommMode to 2.

Step 2. Into **【Options】** → **【Environment】** ,set Upload/Download to USB.

Step 3. Execute Download/Upload function from DopSoft: 【Download All Data】 , 【Upload all Data】 , 【Download Screen】 , 【Upload Recipe】 , 【Download Recipe】 , 【Download Logic Data】 , 【Upload Logic Data】 , 【Download Boot Screen】 , 【Reset default logo】 , 【Firmware update】 , 【Get Firmware Information】 , 【Reset HMI】 .

DopSoft will execute Download/Upload.
